PARTIAL DISCHARGE PATTERNS AND SURFACE DETERIORATION IN VOIDS IN FILLED AND UNFILLED EPOXY.

J.T. Holbøll and M. Henriksen,
Electric Power Engineering Department
Technical University of Denmark
Building 325, DK-2800 Lyngby, Denmark

Abstract

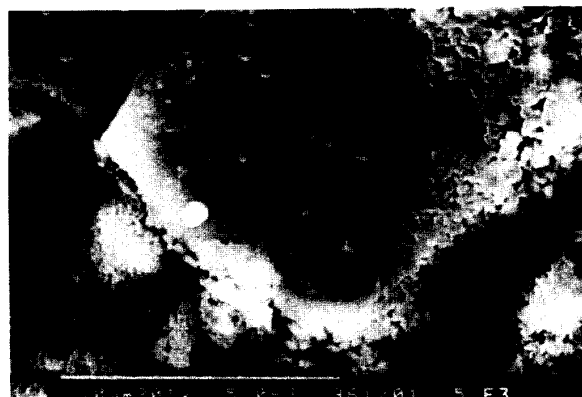
Fig.8: Surface of a spherical void (1.2mm \varnothing) in dolomite filled epoxy after 2400h of exposure to discharges (SEM picture).

Fig.9: Surface of a spherical void (1.2mm \varnothing) in alumina filled epoxy after 2400h of exposure to discharges (SEM picture).

Fig.10: Surface of a spherical void (1.2mm ϕ) in silica filled epoxy after 2400h of exposure to discharges (SEM picture).

As can be seen in fig.8,9 & 10 some of the epoxy was removed from the surface of the filler particles under the exposure to discharges. Unfilled, dolomite and alumina filled epoxy showed an even deterioration, with the epoxy forming round shapes of less than $1 \mu\text{m}$ radius (fig.11). In silica filled epoxy the deterioration seemed to be more severe, but was limited to certain areas (fig.10). The rest of the exposed area was also affected, but only in a degree as seen in the equatorial area.

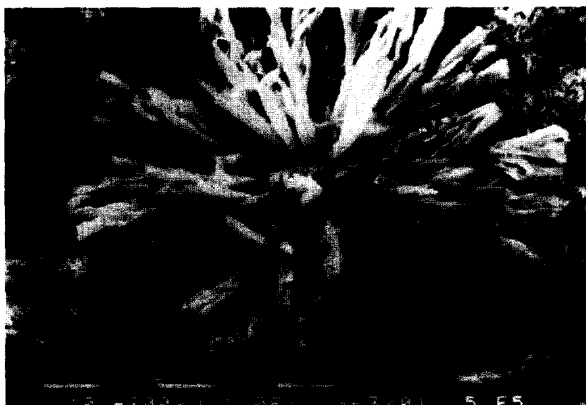
Fig.12: Crystal like structure on the surface of a void in dolomite filled epoxy after exposure to discharges in 2400 hours (SEM picture).

In all of the unfilled and dolomite filled specimens some crystal-like structures were found (fig.12). The crystals could be dissolved in water but not in ethylene. The aqueous solution was non-acidic, which means that the crystals did not contain oxalic acid as earlier suggested [2]. In the same paper it was implicated that these crystals could cause a sudden high discharge activity, which we feel could possibly be due to fieldenhancements by the crystals.
